CONDITION SURVEY OF LOCK NO. 8, MONONGAHELA RIVER

Richard L. Stowe

June 1987

Prepared for US Army Engineer District, Pittsburgh
Pittsburgh, Pennsylvania 15222-4186

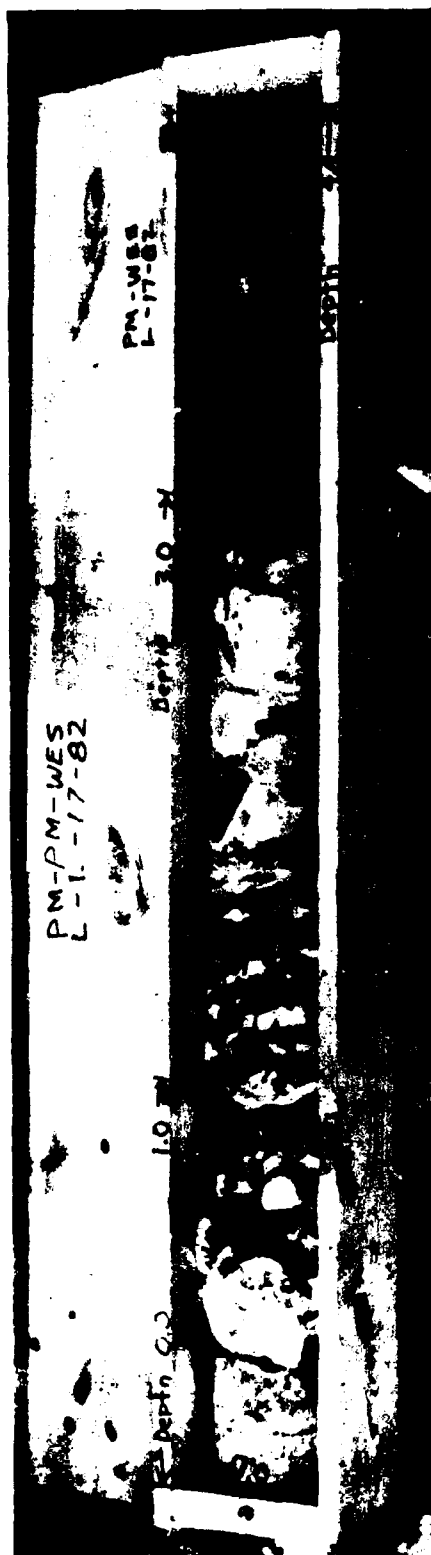
Shotcrete Rubble w/wht subparallel 1.6 ft
 overlay reaction product cracking

a. Typical vertical concrete core, river lock wall

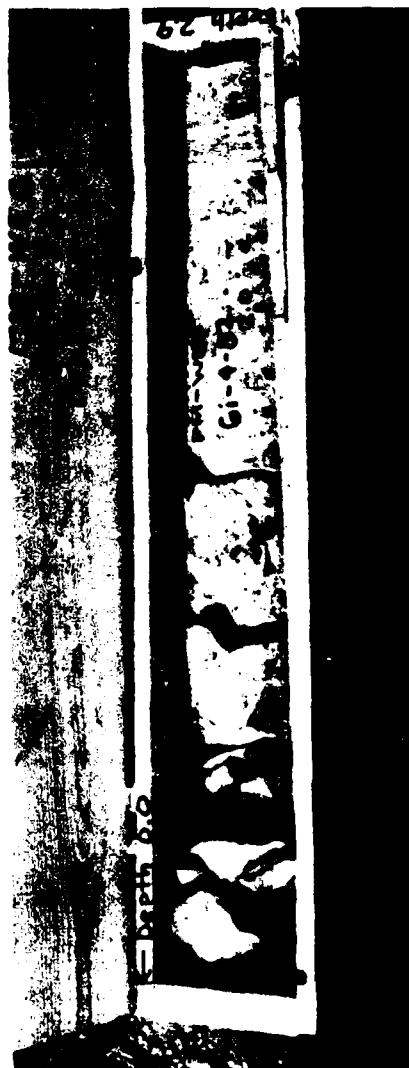
b. Typical horizontal concrete core, lower guide wall

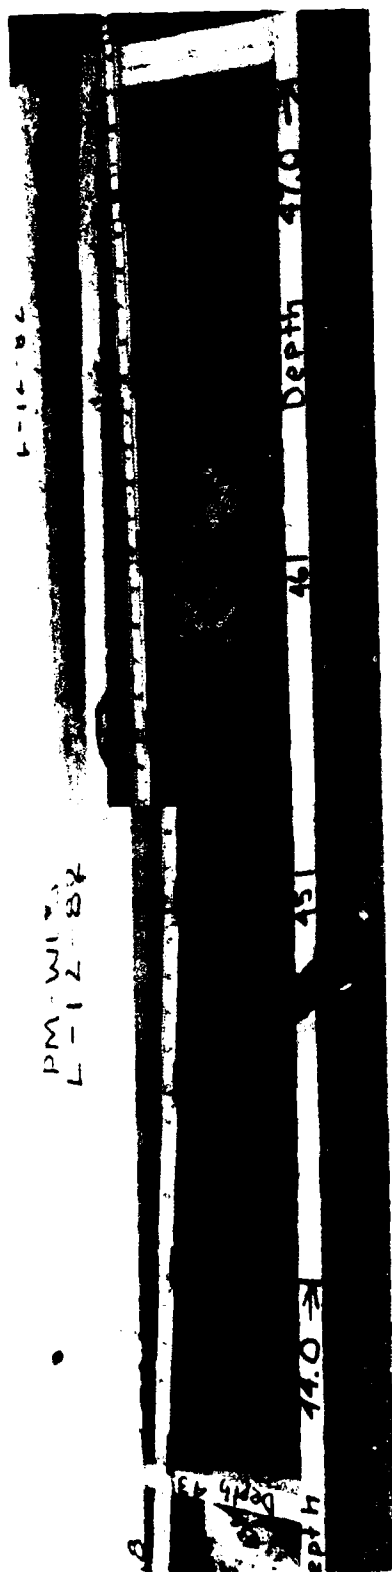
a. Rock from just below river wall, broken during drilling

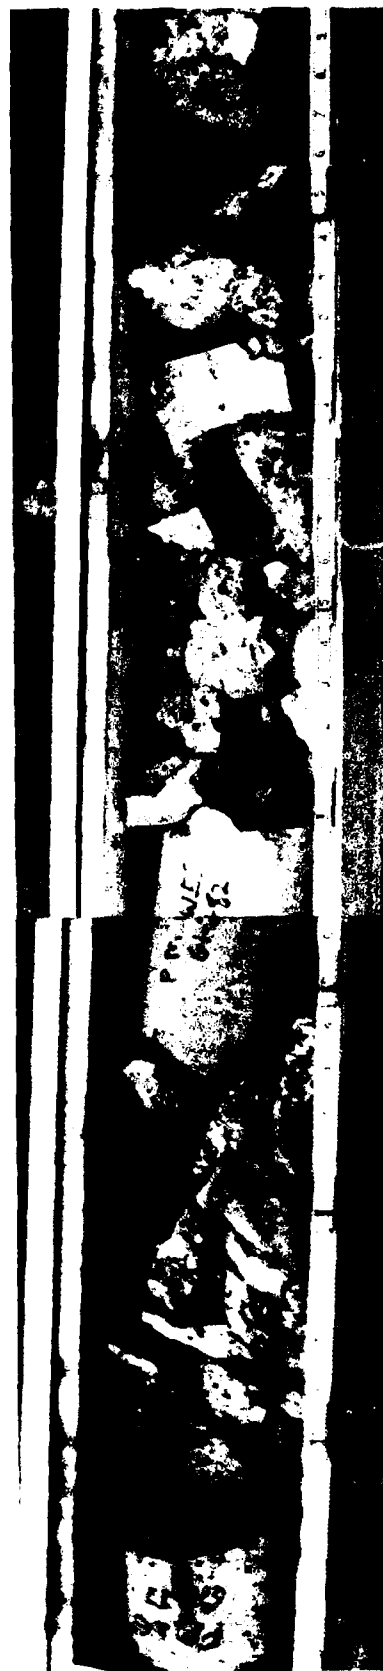
Horizontal boring Gi-2-82, upper miter gate recess, land wall,
showing broken core to full 3.0-ft depth

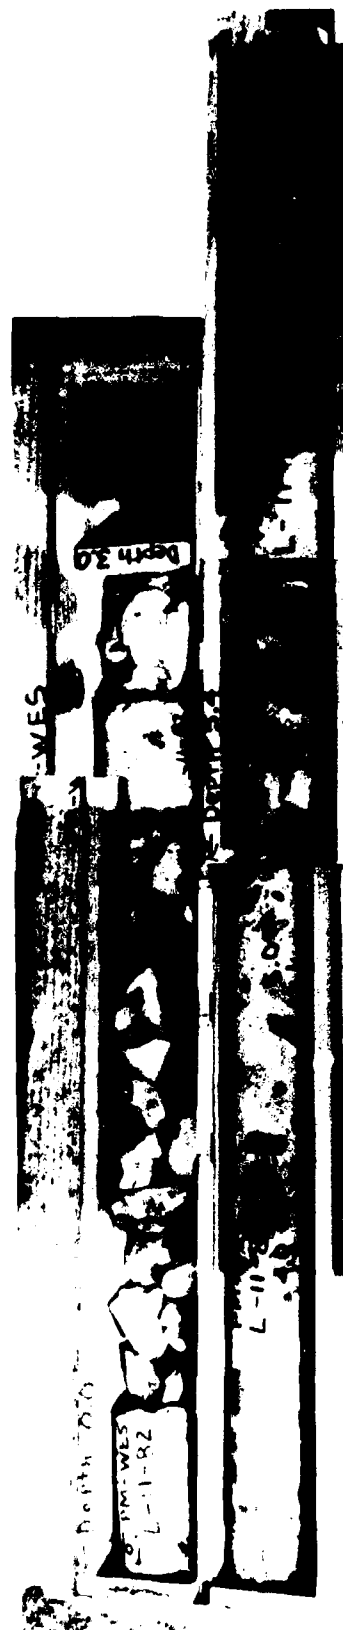
Concrete core L-11-82, vertical boring, upper guard wall; overlay concrete 0.0 to 0.6 ft;
broken core interval 0.6 to 3.0 ft

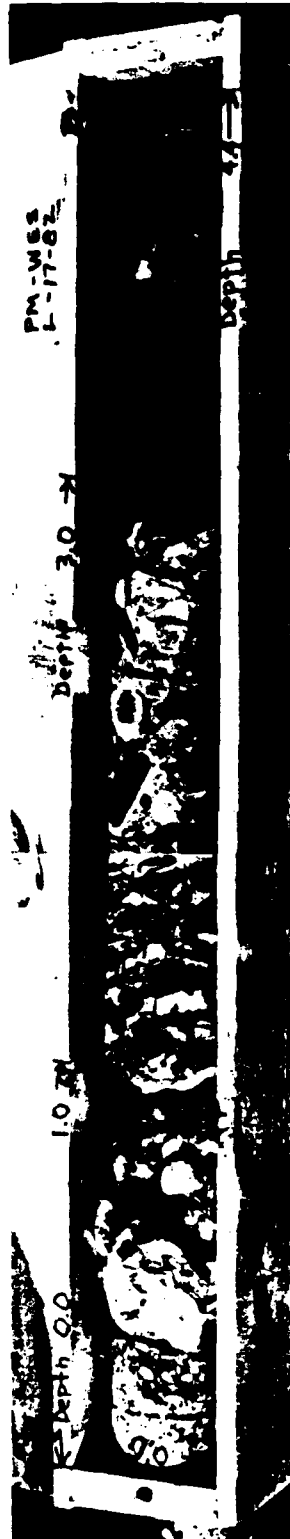
Concrete core L-17-82, vertical boring, lower guard wall; overlay concrete 0.0 to 0.5 ft;
broken and cracked concrete to 1.6 ft

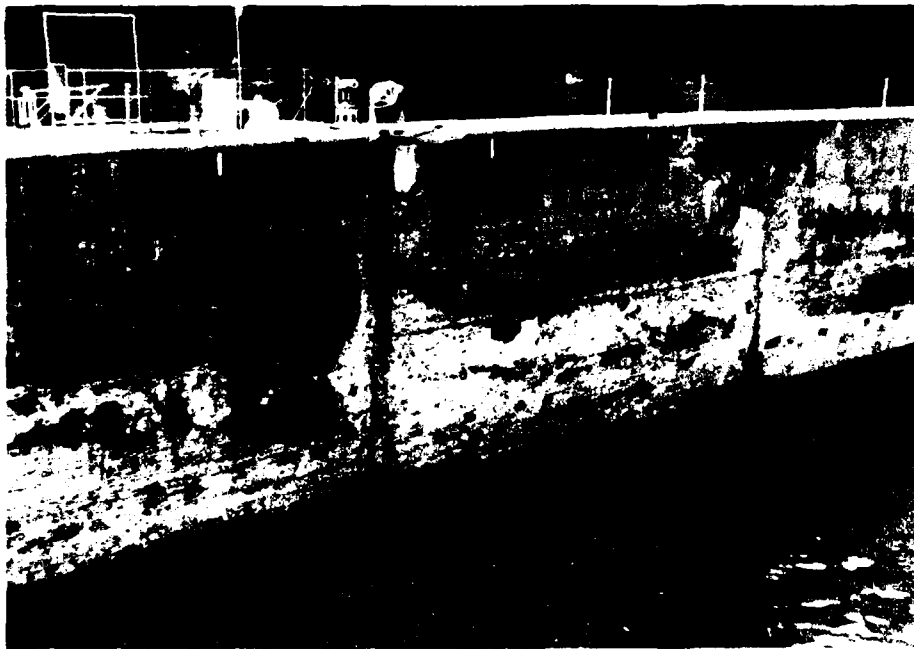
Photo 8. Lower guide wall showing shotcrete removal, construction joint spalls, and scaling, looking downstream from lower guard wall

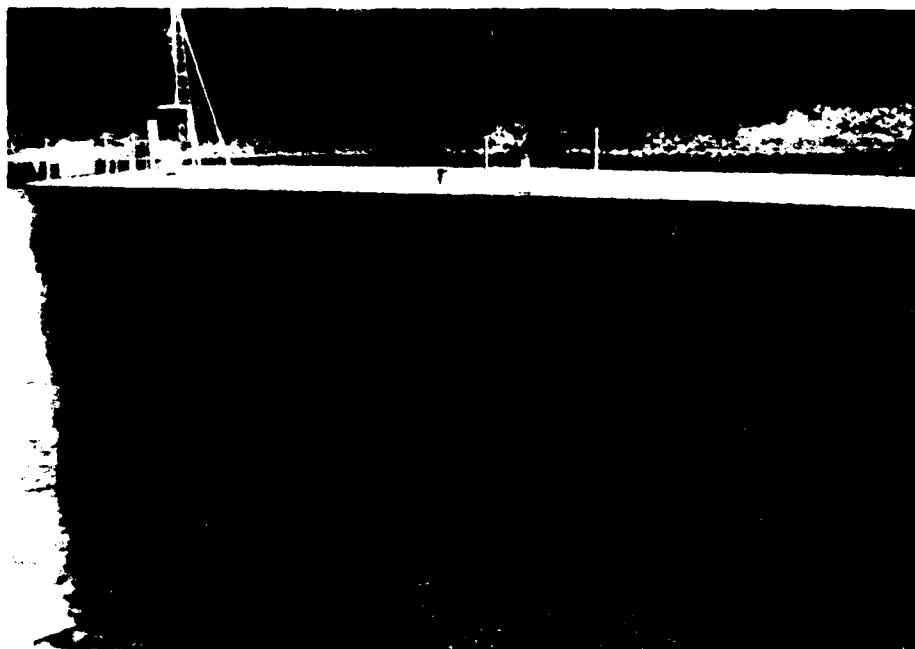
Photo 11. Chamber side face of lower guard wall showing concrete damage, spalling, scaling, cracks, looking downstream and riverward

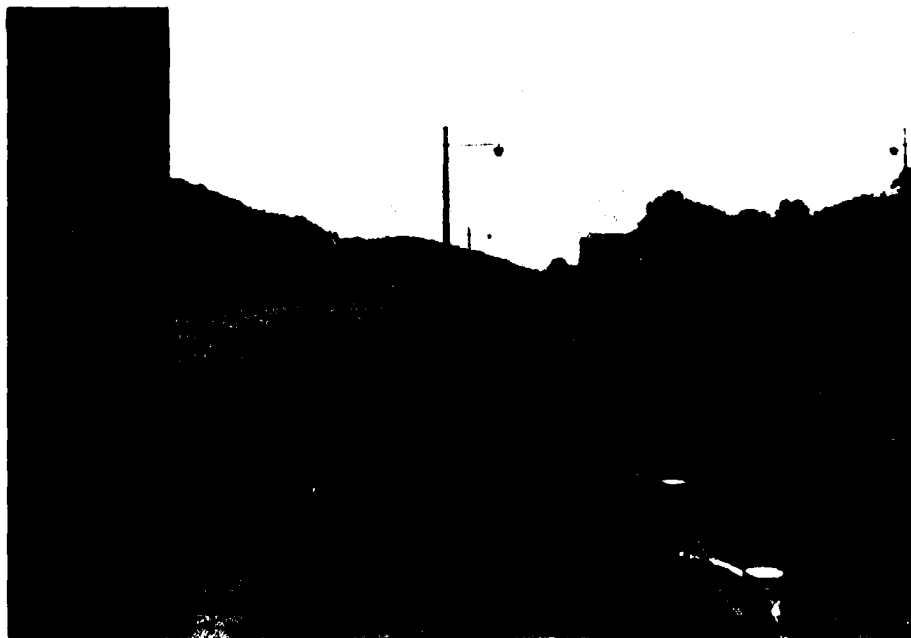
Photo 16. River lock wall showing light color concrete/mortar patches and scaling, looking upstream
